# **INDOOR AIR QUALITY ASSESSMENT**

**State Transportation Building  
Suite 5750  
10 Park Plaza  
Boston, MA**

Prepared by:  
Massachusetts Department of Public Health  
Bureau of Environmental Health  
Indoor Air Quality Program  
August 2019

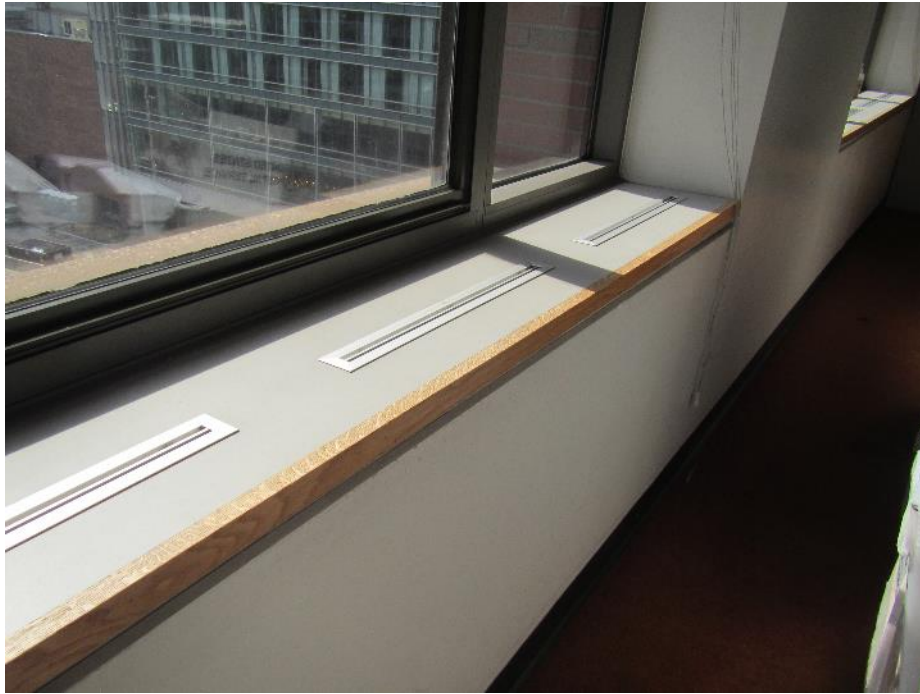
**Picture 1**

Fresh air is supplied by induction units near windows (Picture 1). Return air is drawn through vents around light fixtures using ducted returns (Picture 2). Fresh air is supplied around some lights as well. In some areas, items were on the induction unit cabinets (Picture 3), including plants. This can block the supply of fresh air as well as aerosolize odors and particulates such as dust, mold spores, and pollen. Vents should be kept clear of items. Occupants reported that in some areas the vents were blocked deliberately because of drafts and uncomfortable temperatures. In other areas, occupants reported a lack of airflow from the units, and one person reported that maintenance had been called to repair the unit and needed replacement parts in order to return the system in that office to functioning. Temperature complaints were also made by several occupants.

**Vents along windows**

2. Regularly clean supply and return vents and vent cabinets.
3. Remove items from the top and front of vent cabinets to allow for airflow.
4. Balance the HVAC system every 5 years in accordance with Sheet Metal and Air Conditioning Contractors' National Association (SMACNA) recommendations (SMACNA, 1994).

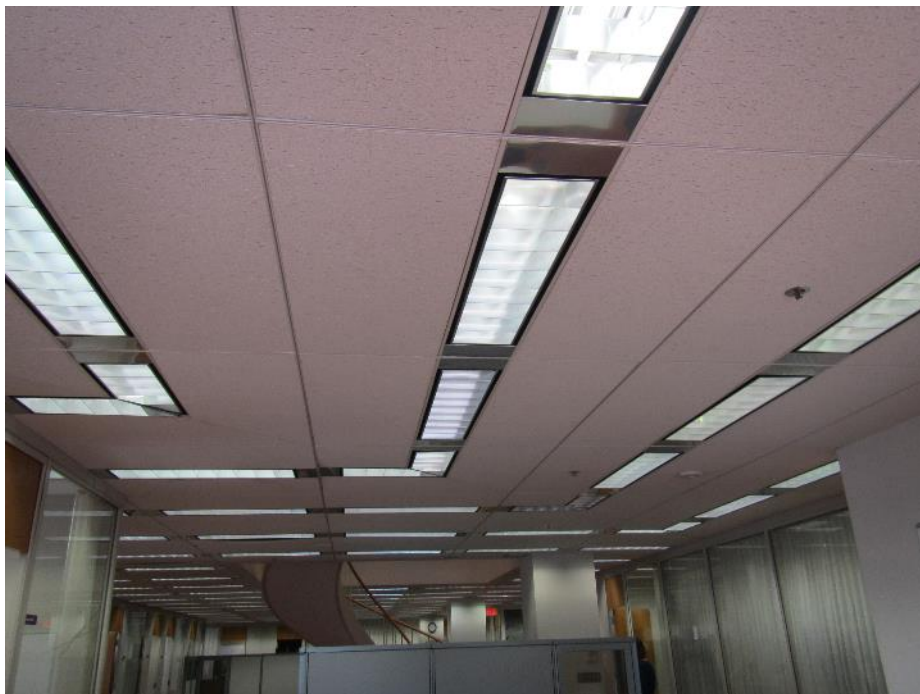
**Picture 2**

**Light fixtures with supply and return vents around them**

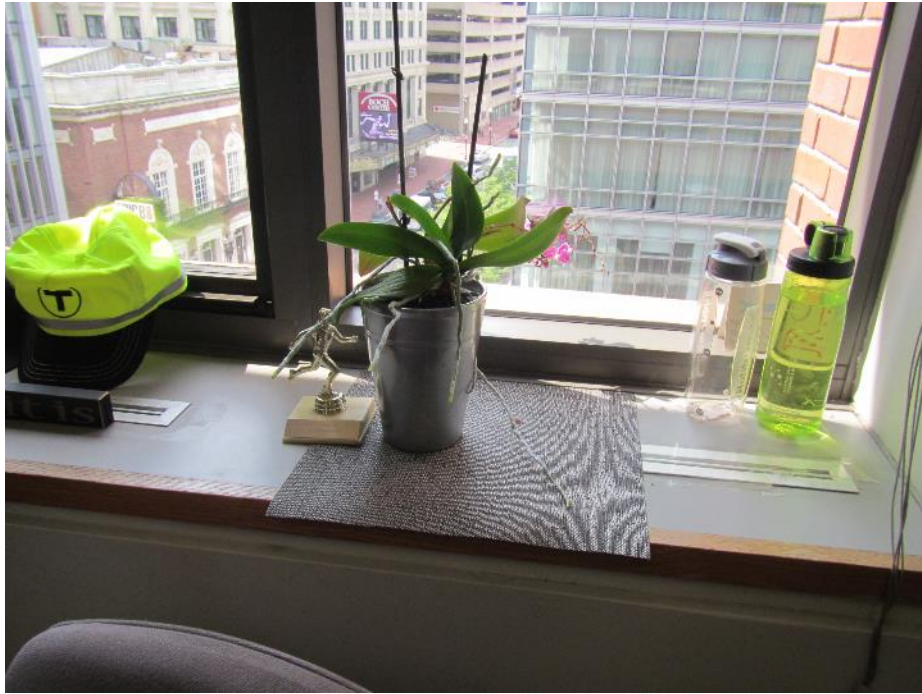
**Picture 3**

As shown in Picture 3, plants were noted in a few areas. Plants should be properly maintained and equipped with drip pans and should be located away from airflow to prevent the aerosolization of dirt, pollen, and mold.

**Items, including plants, on vents**

7. Keep plants and flowers in good condition, avoid overwatering, and remove from the airstream of heating and ventilation equipment.
8. Consider placing refrigerators and water dispensers in areas without carpeting, or use a waterproof mat to protect carpeting.

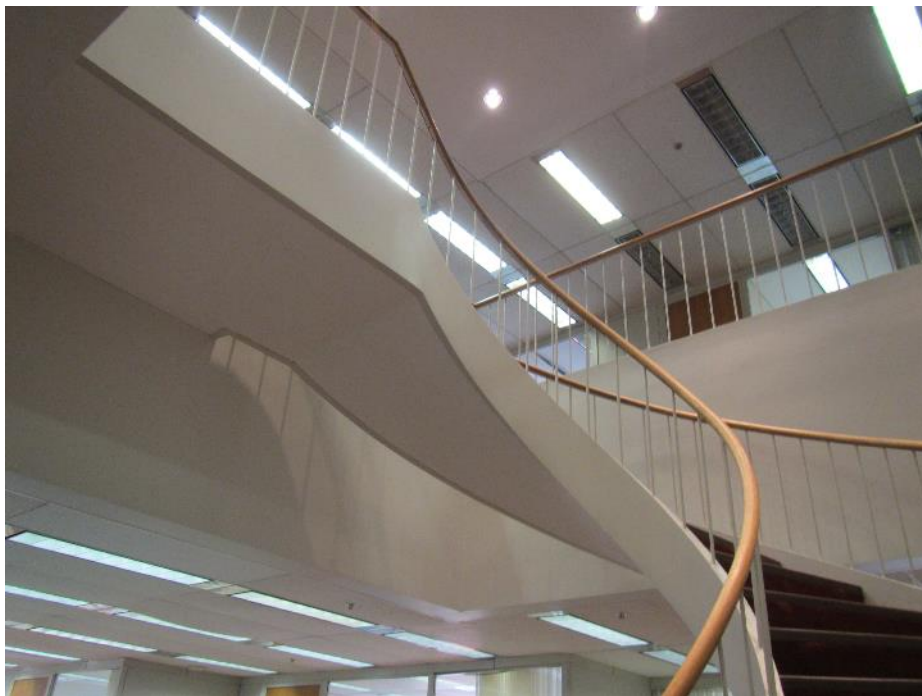
**Picture 4**

Note that this office has a spiral staircase to the next level up located near the reception area (Picture 4). The floor above is used by a different department and was not examined during this assessment. However, this open channel between floors likely complicates airflow balancing.

**Spiral staircase to floor above**

5. Ensure that new uses of the space and the presence of the staircase of the next level are taken into account when airflow is modified and balanced.
6. Replace water-damaged ceiling tiles. Repair any source of leaks as they are discovered.

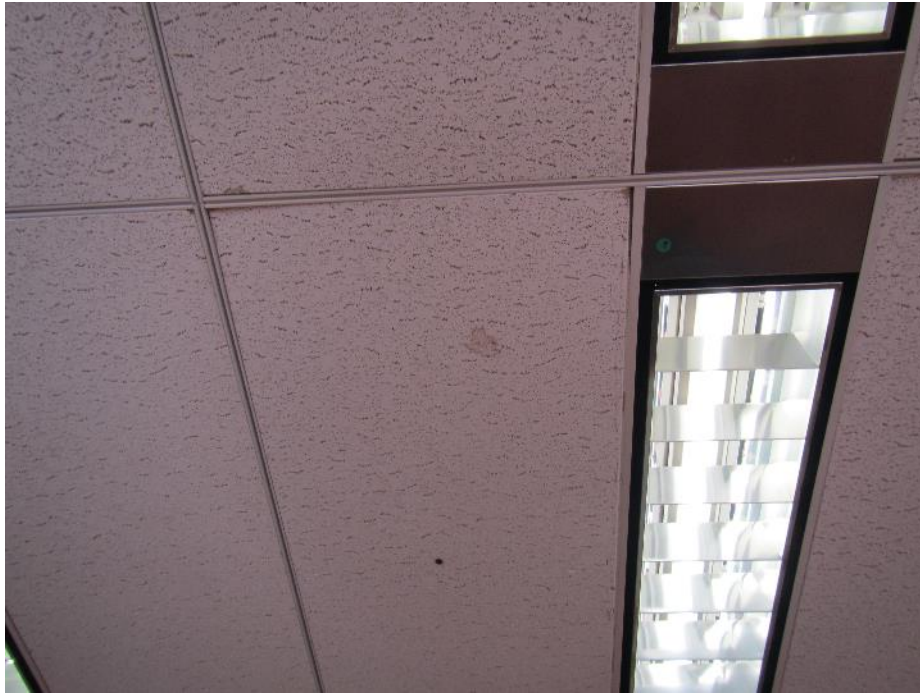
**Picture 5**

Light water stains were noted in two areas (Picture 5; Table 1). This likely is the result of a leak/condensation in the HVAC or sprinkler system. The area above this ceiling tile should be examined for the source of the leak and for any additional water-damaged materials. Once the leak is repaired, the affected ceiling tiles should be replaced.

**Small water stain on ceiling tile**

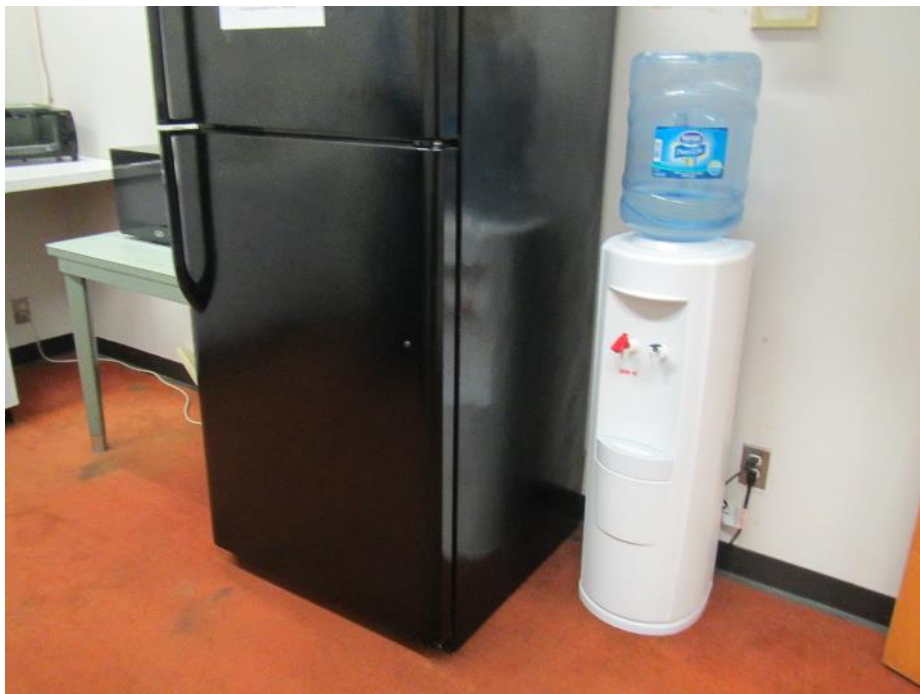
**Picture 6**

Refrigerators and water dispensers were located on carpet, including in the kitchen (Picture 6). Refrigerators and water dispensing equipment should be located in a non-carpeted area or on a waterproof mat to prevent damage to carpet and subsequent odors.

The carpeting in this area of the building appears to be original to the building. It is in poor condition, with numerous stains, tears and uneven areas (Pictures 6 and 10). Carpeting deteriorates over time, and becomes increasingly difficult to clean. This leads to a buildup of dirt, dust, odors and possible microbial contamination. Deteriorating carpeting can also become a source of irritating fiber dust. Carpeting is specifically not recommended in kitchens or other areas where spills, crumbs or similar issues are common. Also note that many of the visitors to this office use wheelchairs. Wheelchairs put additional wear on carpeting due to the increased weight of motorized units, pressure from the relatively small surface area of the wheels on some

**Refrigerator and water dispenser on carpet in kitchen area, note poor condition of carpet**

15. Consider replacement of carpeting in the office suite, including the use of non-porous flooring in areas such as the kitchen.
16. Reduce the amount of items stored on flat surfaces to allow regular cleaning.

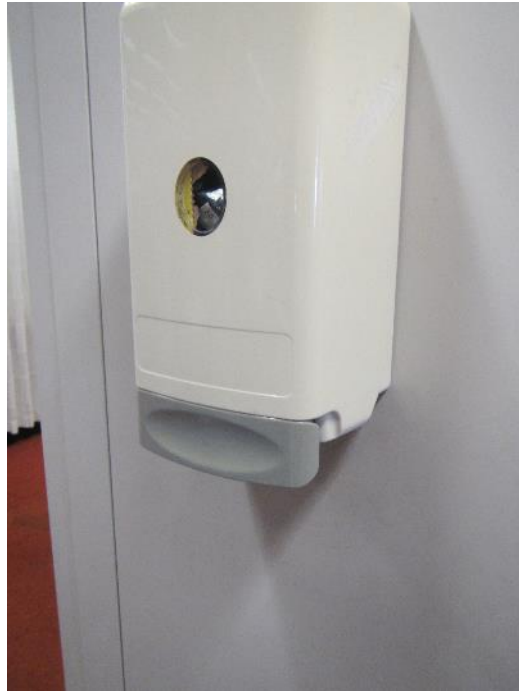
**Picture 7**

measurements for TVOCs and examined spaces for products containing VOCs. While VOC levels were not detected (ND) in the areas examined, BEH/IAQ staff noted hand sanitizers, air fresheners, and dry erase materials in the office space (Picture 7; Table 1). All of these products have the potential to be irritants to the eyes, nose, throat, and respiratory system of sensitive individuals. Note that this office provides services to people with disabilities, some of whom visit the office for hearings or meetings. Conditions such as asthma, migraine headaches or chemical sensitivity issues can be exacerbated by exposure to TVOCs. Fragrances used in air freshener products in particular can be an irritant and trigger for other health problems. Note that fragranced products do not remove odors, but merely mask them with another scent. For more information, the MDPH guidance “Clean Air is Odor Free” is attached as [Appendix A](#).

**Hand sanitizer dispenser in the office**

10. Reduce the use of cleaning products, sanitizers, and other items that contain VOCs.
11. Consider the use of a "scent free" office policy to protect occupants and visitors. Review [Appendix A](#) ("Clean Air is Odor Free") for more information on fragrances.

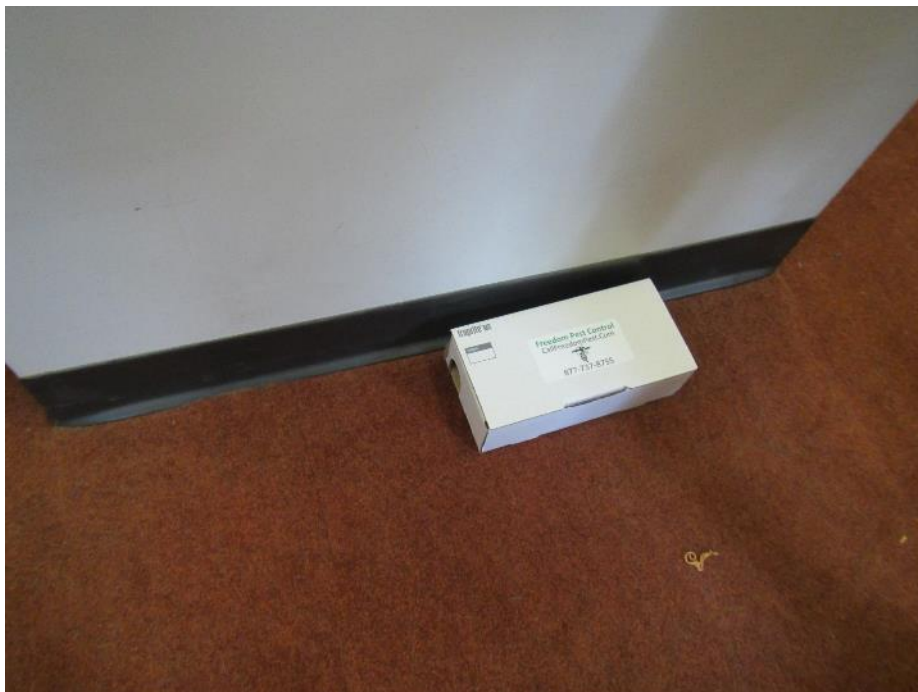
**Picture 8**

Food and food preparation equipment was observed in some offices and common areas. Food should be kept tightly sealed to prevent pest access and food preparation equipment should be kept clean to prevent smoke, odors and pests. Pest control equipment such as rodent bait traps and sticky traps were seen in various locations in the office (Pictures 8 and 9). If pests are an issue in this office, it is even more important to keep food tightly sealed and food preparation equipment clean. Harborage/nesting areas, such as papers and boxes should be removed, and any gaps between occupied and unoccupied spaces should be sealed to further discourage rodents. Note that rodents can be a source of allergens from their dander and wastes. Even if the rodents are removed, additional cleaning is required to remove the materials that may lead to allergic reactions.

**Pest control rodent trap**

14. Use the services of a licensed pest contractor to control rodents and other pests as needed. Increase cleaning in areas where rodents/pests were present to remove allergens.

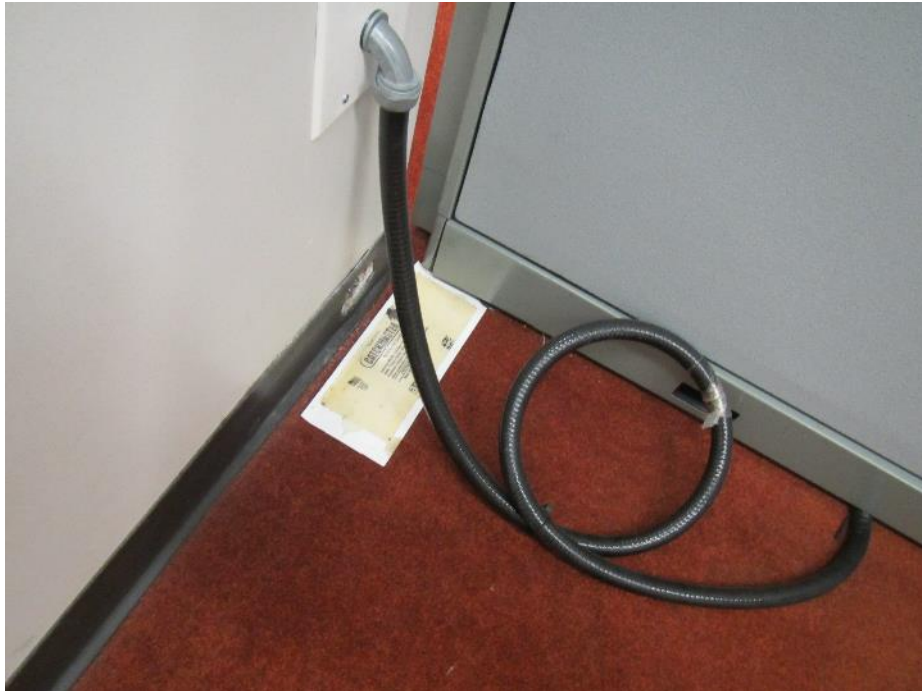
**Picture 9**

**Sticky trap for rodents and insects**

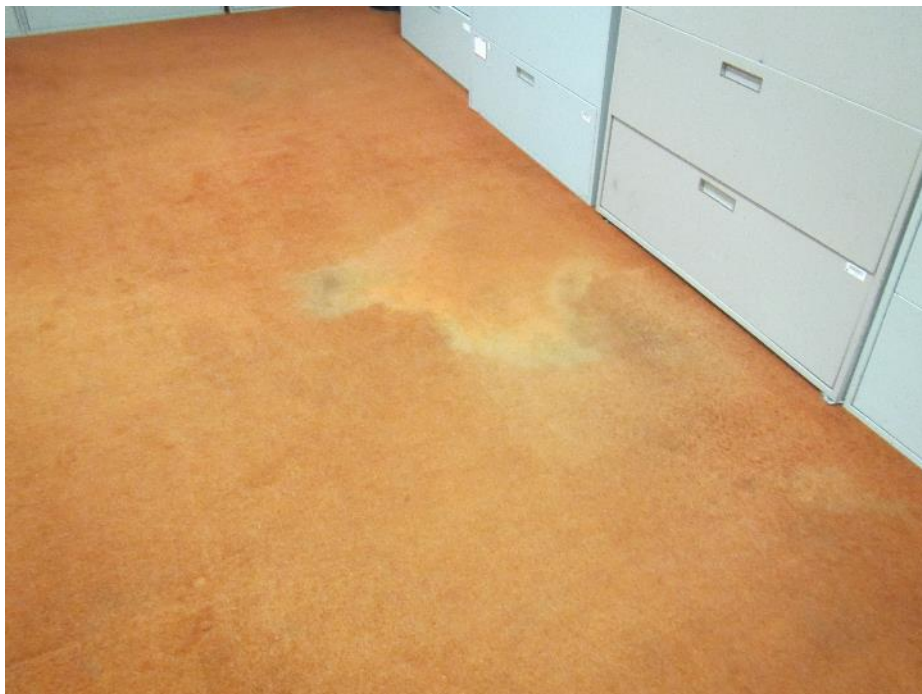
**Picture 10**

**Stained, wrinkled, worn carpeting**

17. Clean carpeting in accordance with IICRC recommendations (IICRC, 2012). Consider a plan for replacement of carpeting in this office suite. The plan should include the use of non-porous flooring (e.g. floor tile) in areas such as kitchens.
